UNDERWATER BRIDGE INSPECTION REPORT

STRUCTURE NO. 36516

BEAVER BROOK

DISTRICT 1 - KOOCHICHING COUNTY

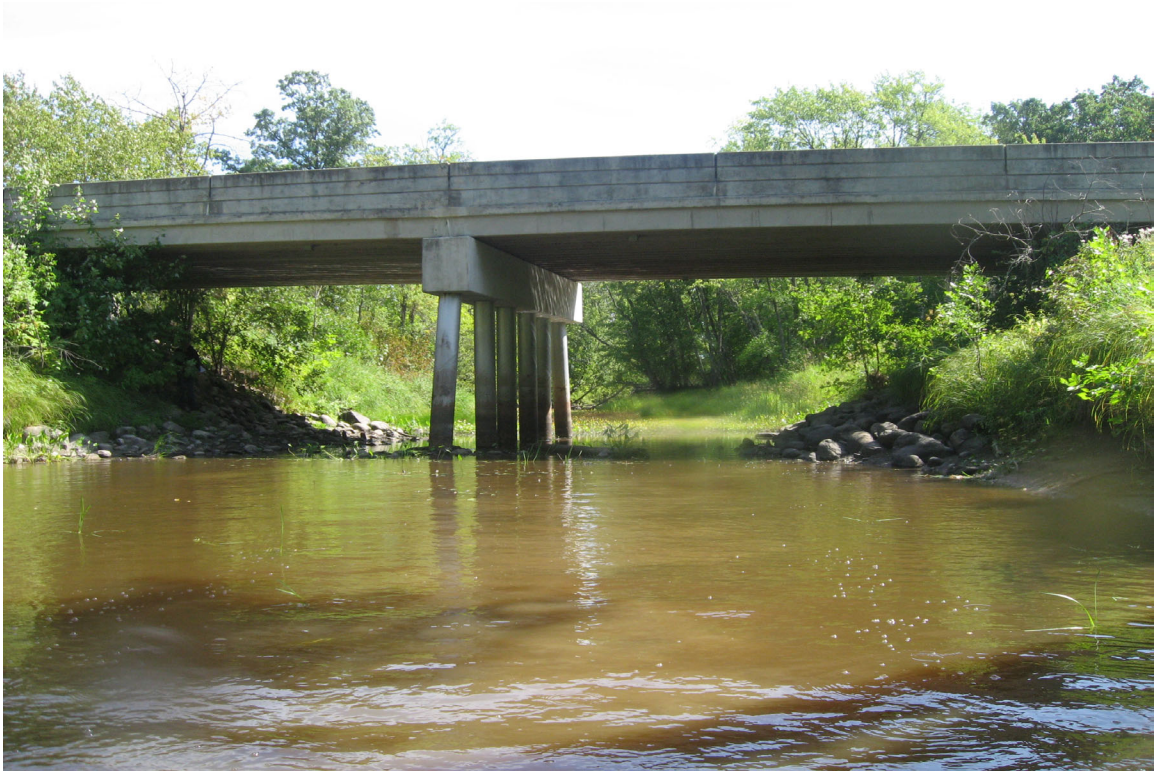
The substructure unit inspected below water at Bridge No. 36516, Pier 1, was found to be in good condition with no defects of structural significance observed. The channel bottom appeared stable with no significant scour and no significant changes since the last inspection.

Photograph 1. Overall View of Bridge, Looking East.

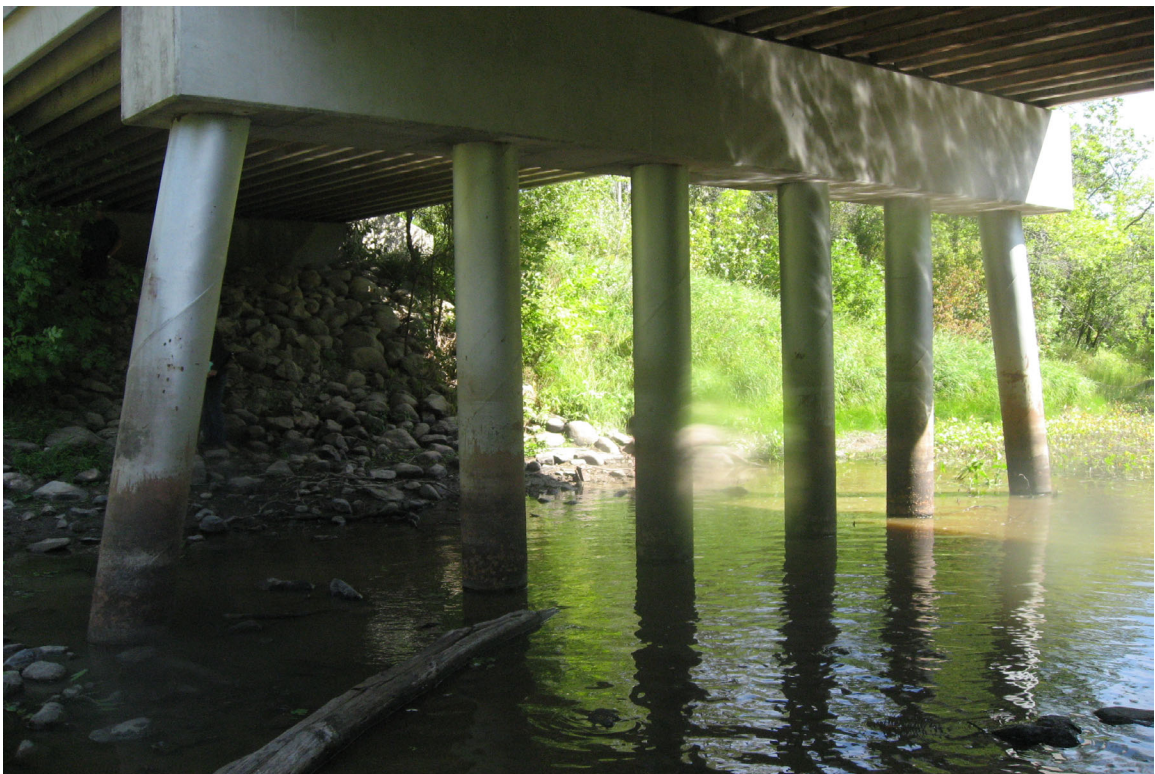
- (A) Random areas of coating failure and light surface corrosion were observed on all piles with some minor pitting, but with no significant section loss or other defects observed.
- (B) There was some light timber drift on the channel bottom scattered amongst the pier piles.

Photograph 2. View of Pier 1, Looking Northeast.

REMARKS: The steel shell piles were in good, sound condition, with 50% coating failure, and up to 25% nodular corrosion, with nodules ranging in size from 1/4 inch diameter to a maximum of 2 inch diameter. When removed, nodules revealed typical pitting with depths ranging from 1/32 inch penetration to 1/8 inch of penetration. Channel bottom appeared stable with no significant changes since the last inspection.

- (A) Reinspect the submerged substructure units at the normal maximum recommended (NBIS) interval of five (5) years.
